# BEECHCRAFT BONANZA/BARON

## Lower Cabin Door Reinforcement

**FAA / PMA Approved (STC SA01422AT-D)**

This STC is applicable to the Bonanza A36, A36TC/B36TC,  
V35B, F33A and 58 (Baron)

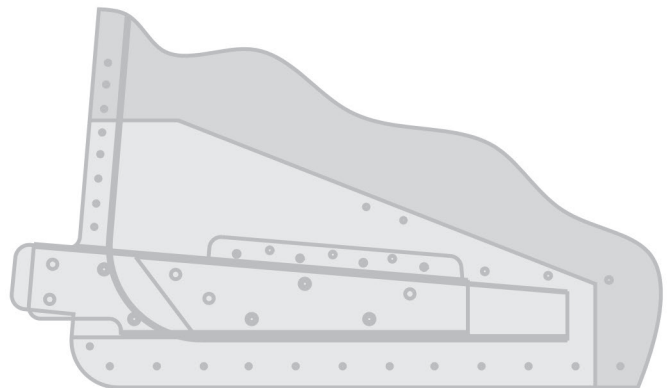
Check your lower cabin door hinge and see if it is loose. If the lower hinge on the cabin door is loose it typically means that cracks have developed around the lower cabin door hinge. These cracks result from the load imposed by passengers or wind attempting to open the door beyond its limits. If left unattended, this problem could lead to a major repair or replacement of the cabin door.

Summit Aviation Mfg has obtained a STC to modify the lower cabin door hinge area by incorporating a reinforcing stiffener. This modification will prevent the further propagation of cracks around the hinge area and protect the door from further damage.
